**OAKLEAF SPORTS COMPLEX CAPITAL EXPENDITURE –
SPORTS HALL AND SQUASH COURT FLOORING MAINTENANCE**

AGENDA ITEM No. 13

MEETING: RECREATION COMMITTEE
DATE: 8TH JULY 2026
REPORTED BY: SPORTS COMPLEX MANAGER

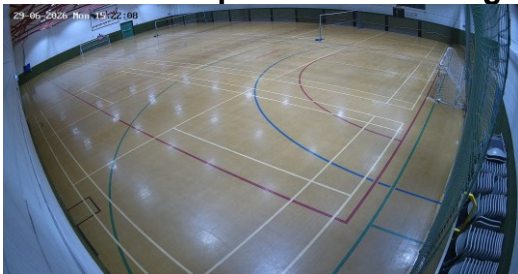
Picture 1 – Sports Hall Flooring

3.3 The work previously undertaken was a specialist task, completed to an excellent standard, and has performed extremely well over time, particularly considering the high levels of multi-use the facility has experienced. The surface remains in very good condition overall, with only minor scratches and small areas of damage evident, consistent with normal wear and tear.

- 4.3 This process will enhance the appearance, performance, and durability of the existing floor while maintaining its current structure.
- 4.4 The works are expected to take approximately three days to complete, followed by a curing period of up to four days, during which time the Sports Hall will be out of bounds (a total of seven days out of use). This temporary closure is necessary to allow the sealant to fully cure and ensure a durable, high-quality finish, preventing any damage to the newly treated surface and maintaining the long-term performance of the flooring.

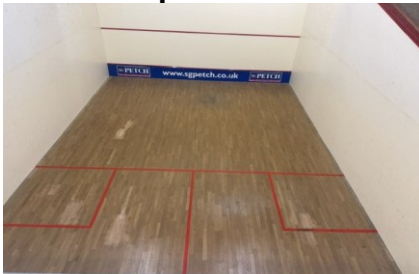
Picture 3 – Squash Court Flooring

3.4 Undertaking the work to both the sports hall and squash court floors at the same time is justified to maintain consistent standards across the facility and ensure both areas remain safe, functional, and fit for purpose. Both floors are subject to regular, intensive multi-use, and although they have performed well, signs of wear such as minor scratches and surface damage are now evident.

- 4.12 The works will comprise the machine sanding of the existing Junckers strip timber squash court flooring to achieve a consistent medium finish on each individual court. Upon completion of the sanding process, each court will be accurately marked out and a new set of red line markings applied in accordance with squash court specifications.
